UNITED STATES DISTRICT COURT
FOR THE EASTERN DISTRICT OF NEW YORK

ALEX MOUSSAVI, P.E., being duly sworn, deposes and says that:

6. On February 5, 2015, I performed a structural inspection of the property located at 490 MacDonough Street, Brooklyn, NY 11233. The purpose of the inspection was to evaluate the major systems of the building such as foundation, structure, heating system, electrical system, plumbing system, roofing, exterior siding, the interior rooms and specifically the ground level apartment. A report of my findings, which I hereby certify as accurate, is attached hereto as Exhibit "B".

Subject: 490 MacDonough Street, Brooklyn, NY 11233
Report# 609709

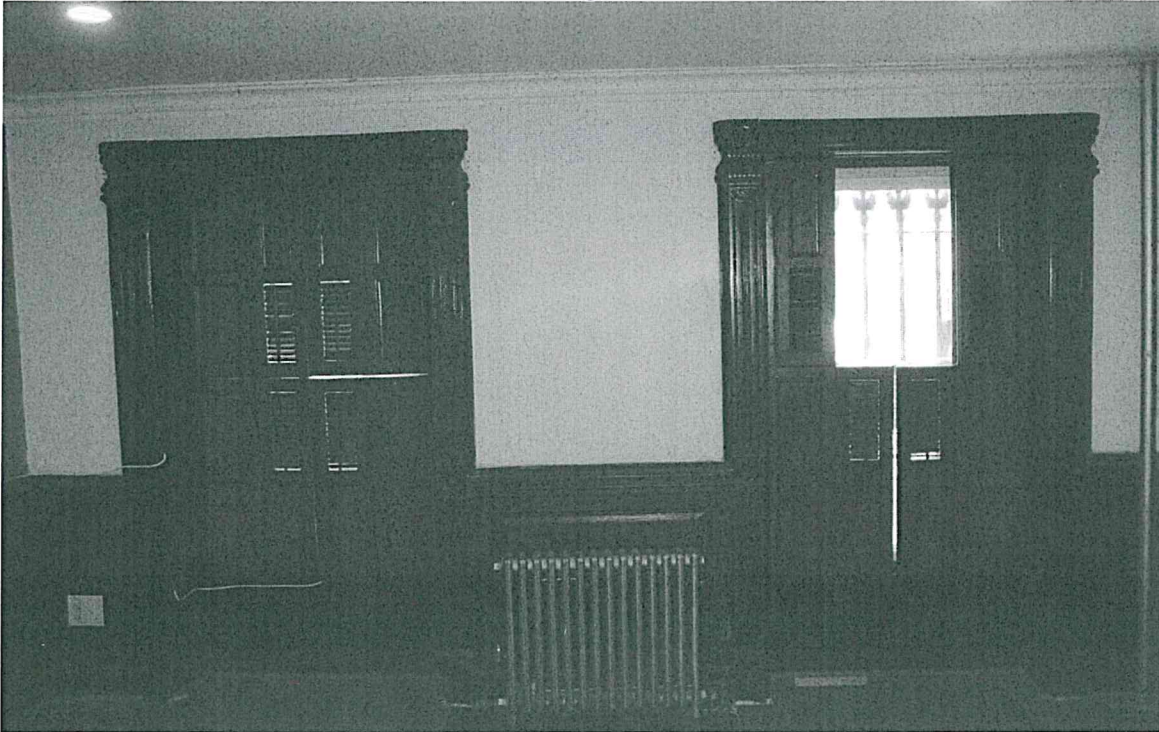
Photo 27

View of the north wall of the bedroom of the ground level apartment.

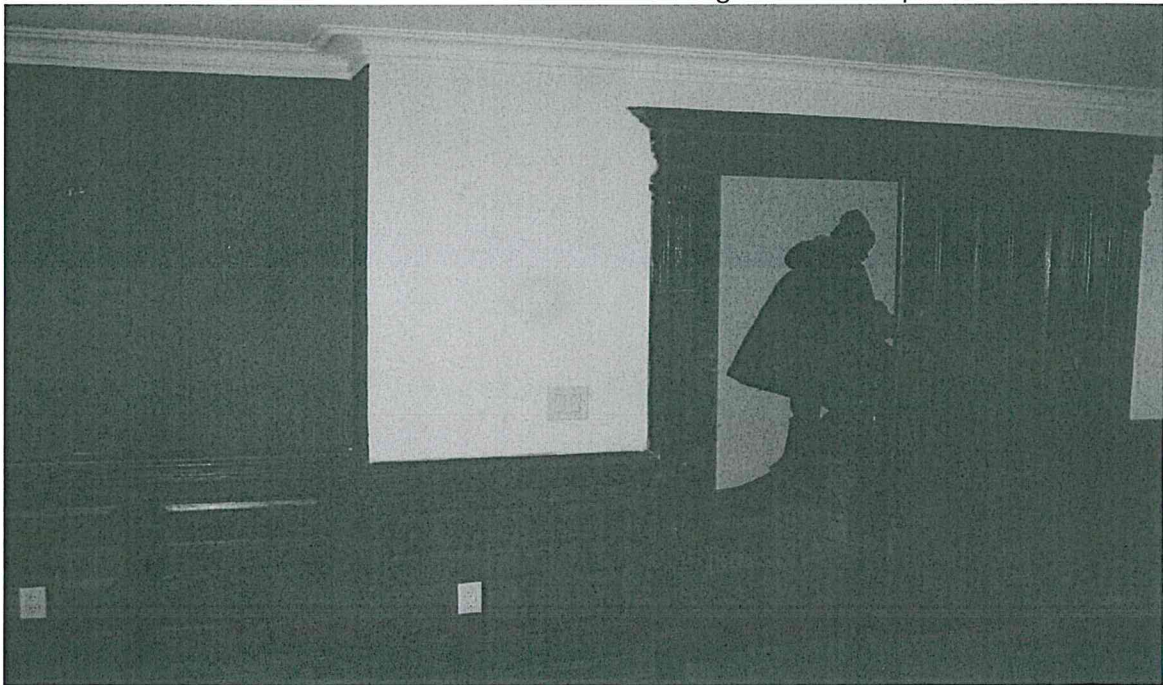
Photo 28

View of the east wall and doors of the bedroom of the ground level apartment.

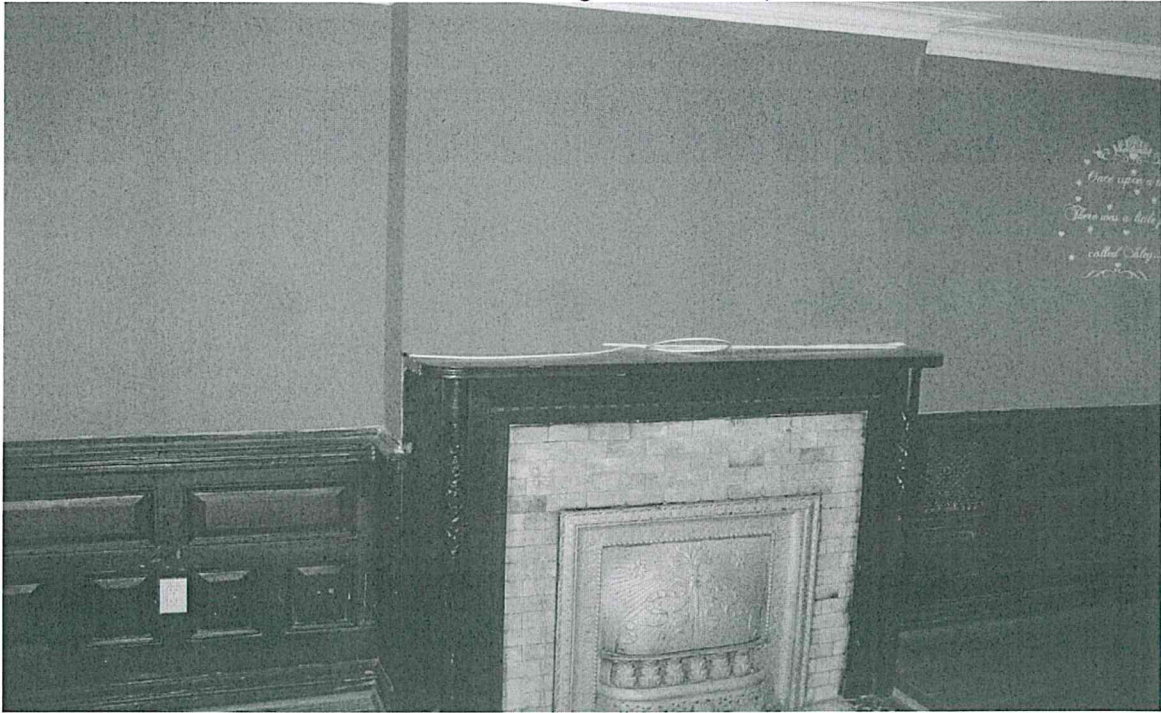
Photo 29

View of the west wall of the bedroom of the ground level apartment.

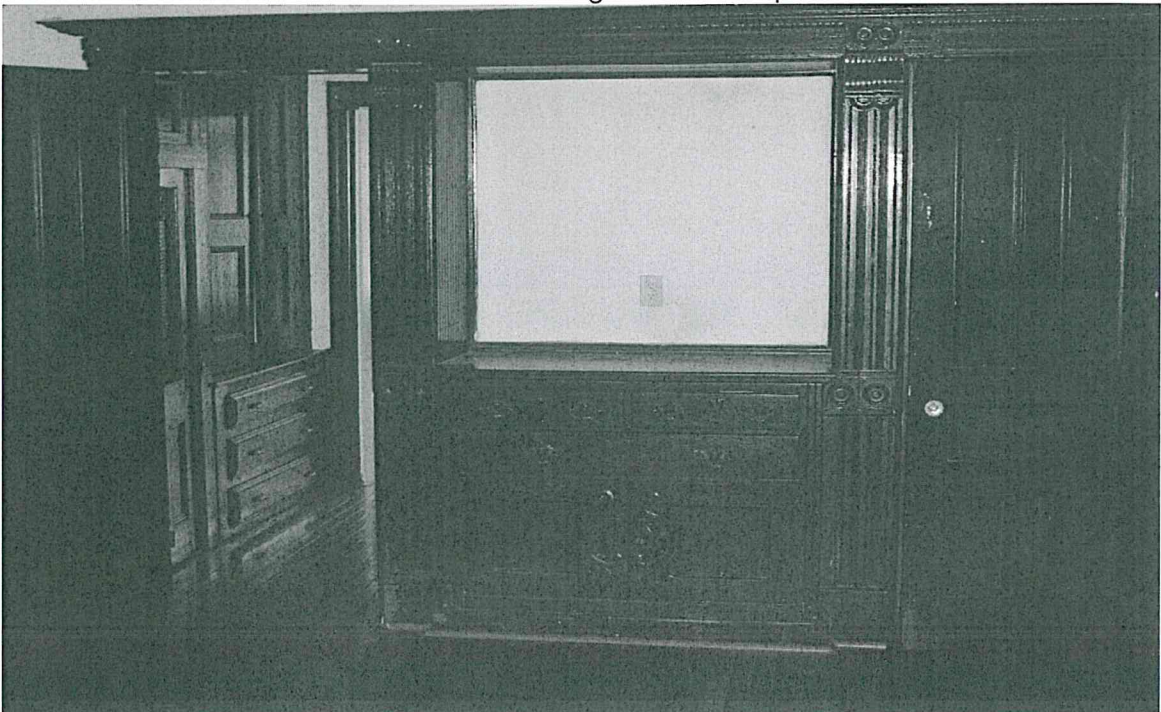
Photo 30

View of the south wall of the bedroom of the ground level apartment.

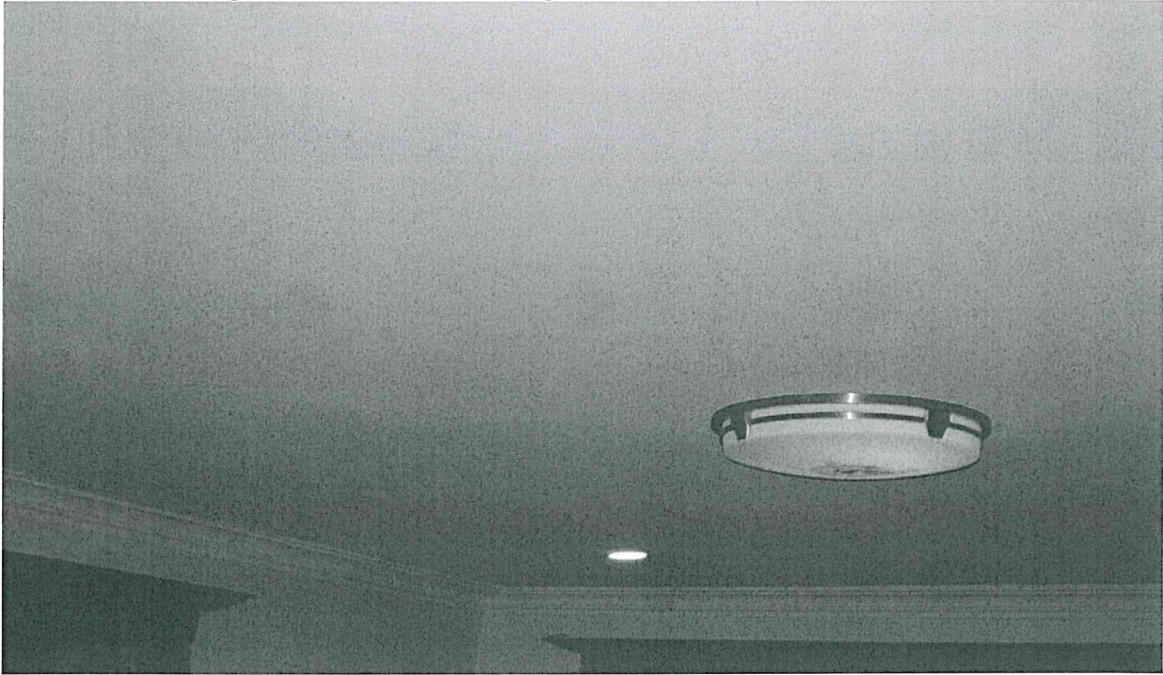
Photo 31

View of the ceiling of the bedroom of the ground level apartment.

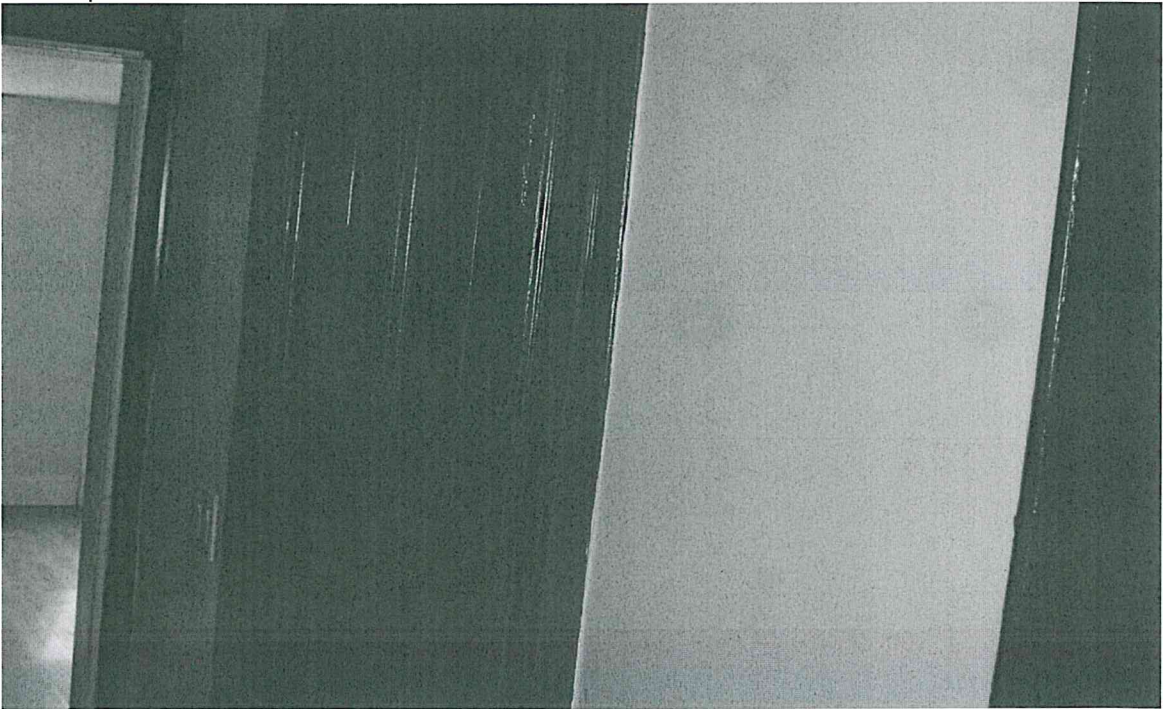
Photo 32

View of the west wall of the hallway between the bedroom and living room in the ground level apartment.

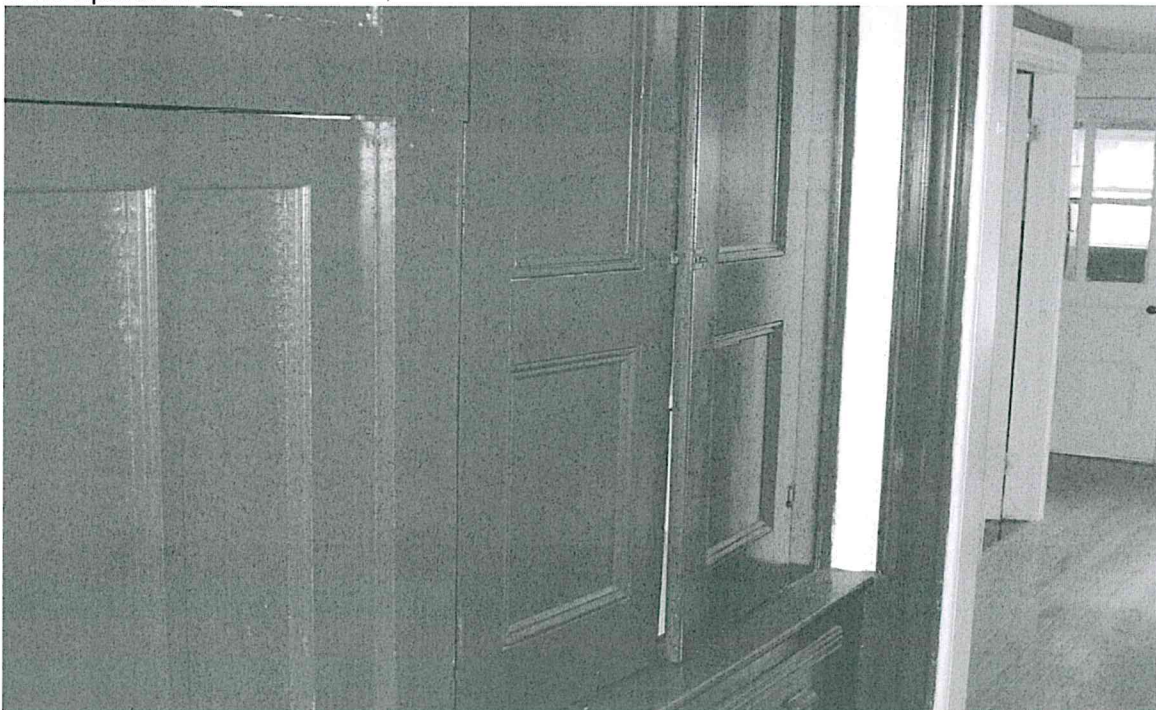
Photo 33

View of the east wall of the hallway between the bedroom and living room in the ground level apartment.

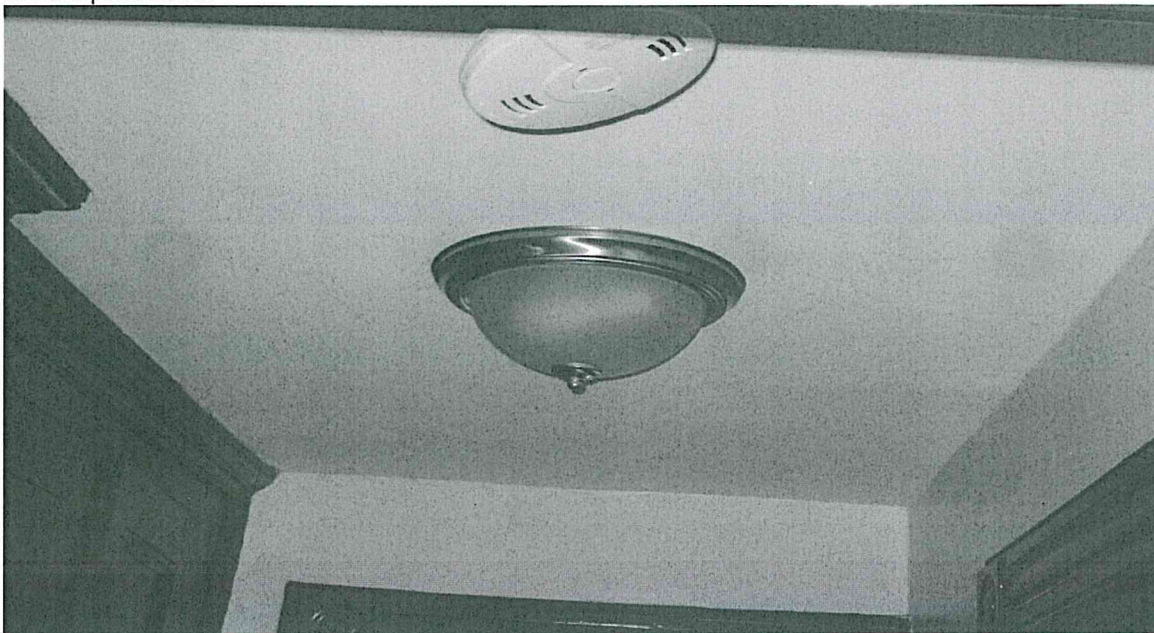
Photo 34

View of the ceiling of the hallway between the bedroom and living room in the ground level apartment.

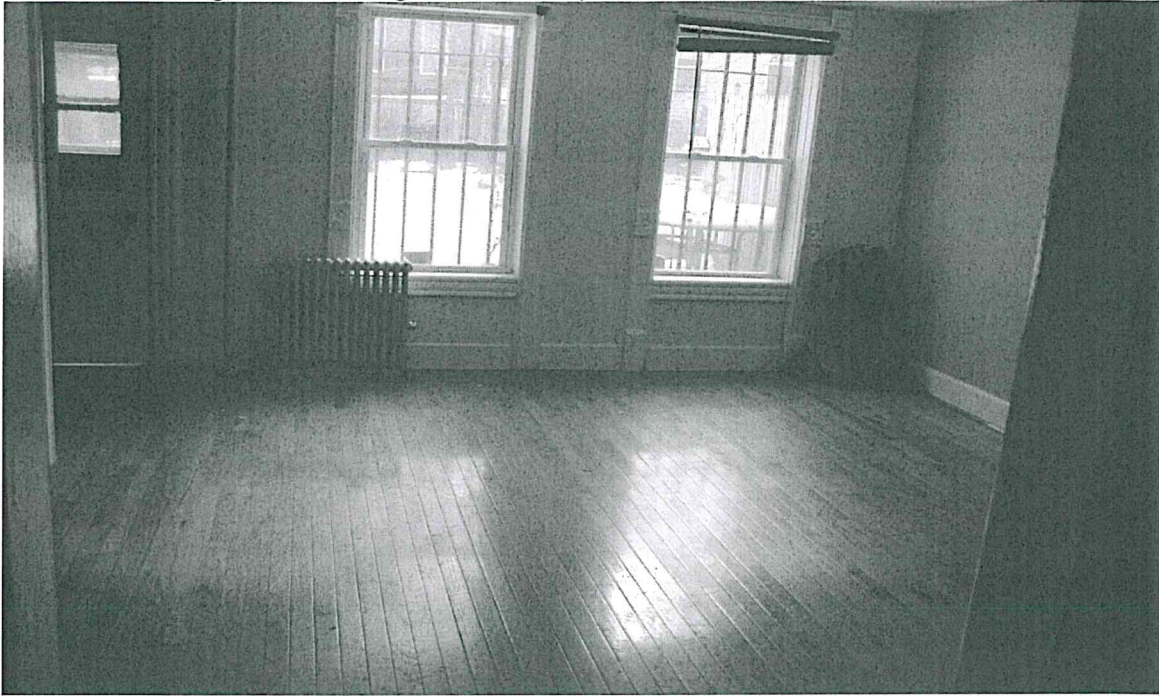
Photo 35

We inspected the living room of the ground level apartment. The floor covering was hardwood floor and in satisfactory condition. The wall and ceiling coverings were drywall material and installed in 2011. The drywall wall and ceiling coverings were installed over the old plaster walls and ceiling. The new drywalls were the proper method of encapsulating the old lead paint covered plaster walls and ceiling. The drywall wall and ceiling coverings were inspected and found to be in overall satisfactory condition and were constructed as per the engineering and construction industry design standards.

View of the living room of the ground level apartment.

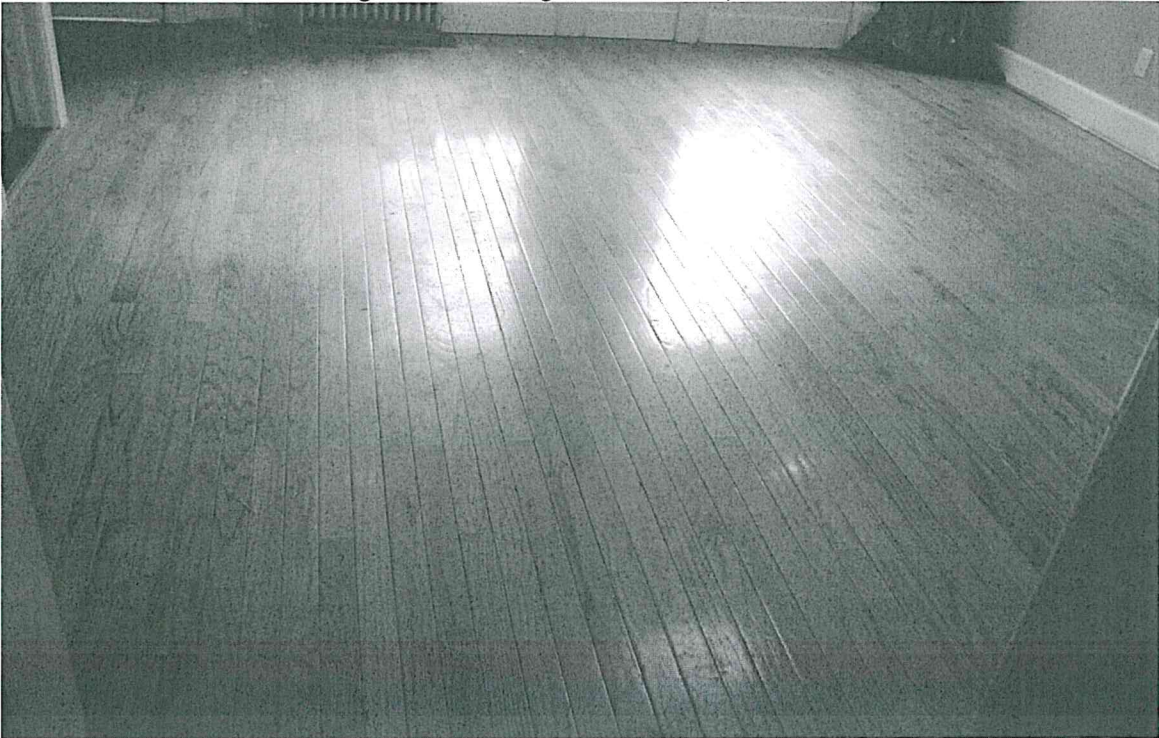
Photo 36

View of the floor of the living room in the ground level apartment.

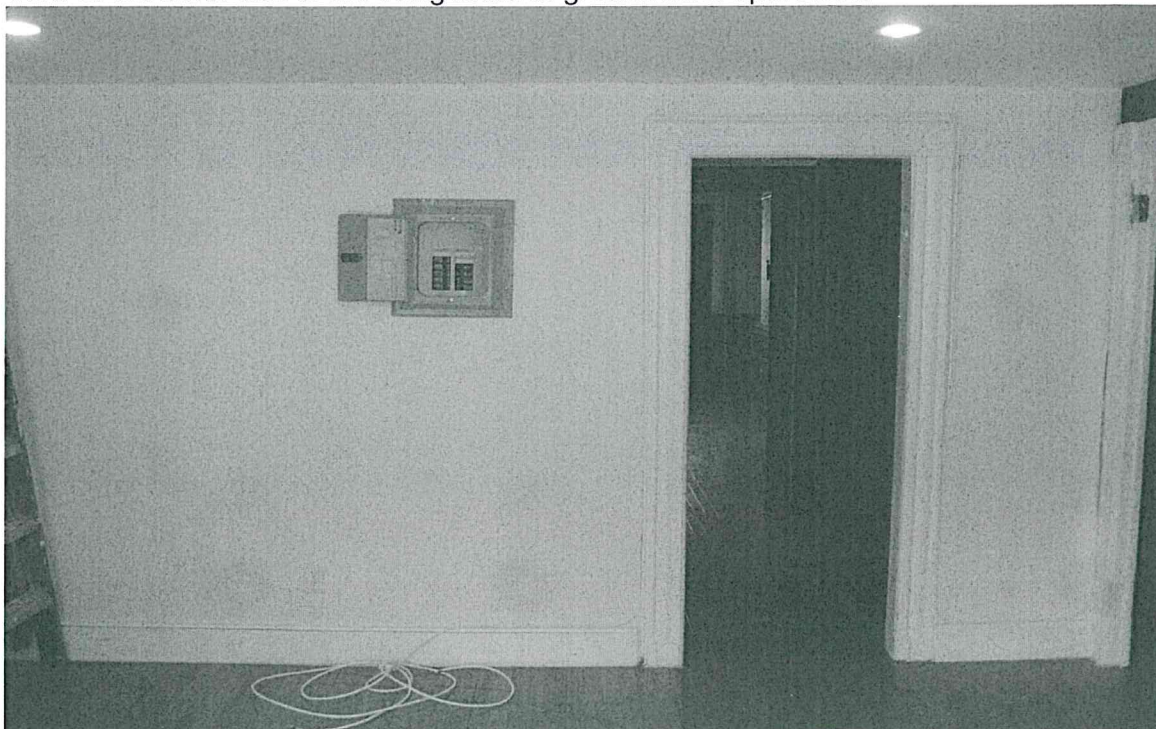
Photo 37

View of the north wall of the living room of ground level apartment.

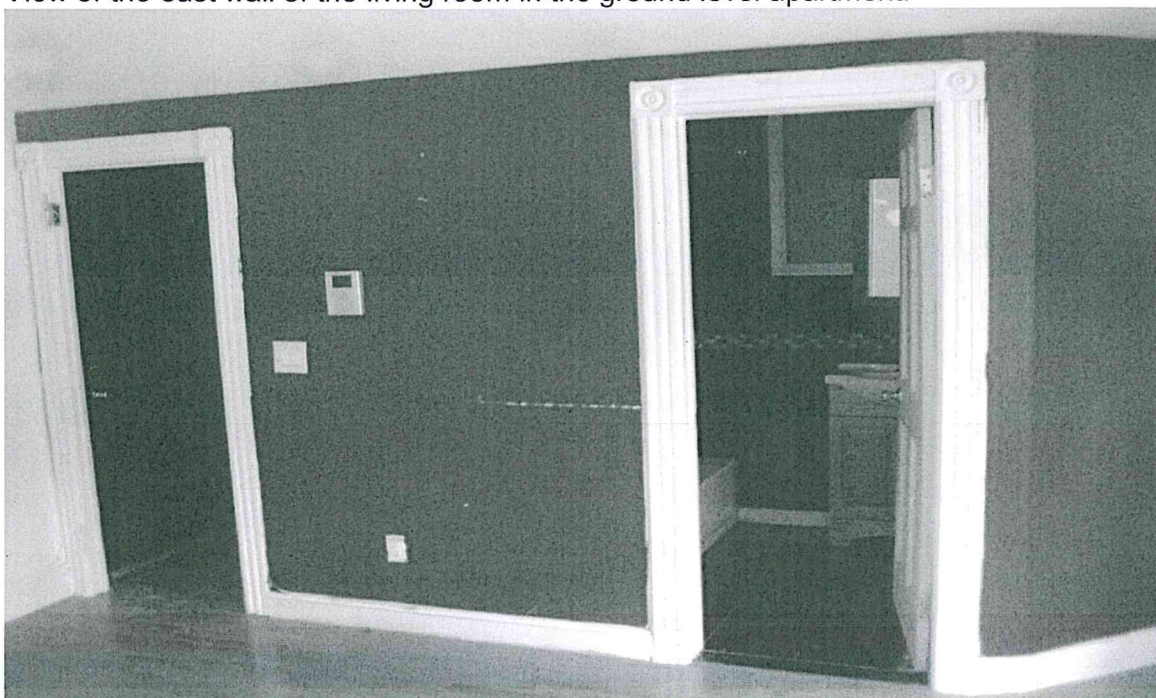
Photo 38

View of the east wall of the living room in the ground level apartment.

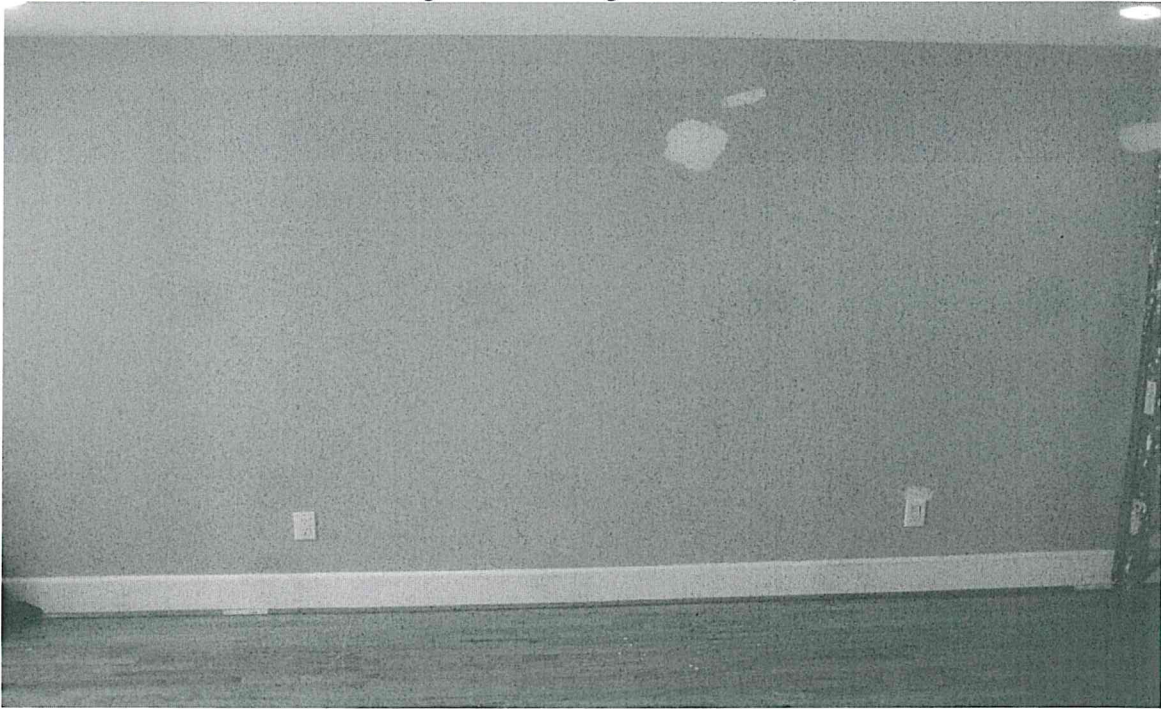
Photo 39

View of the west wall of the living room of the ground level apartment.

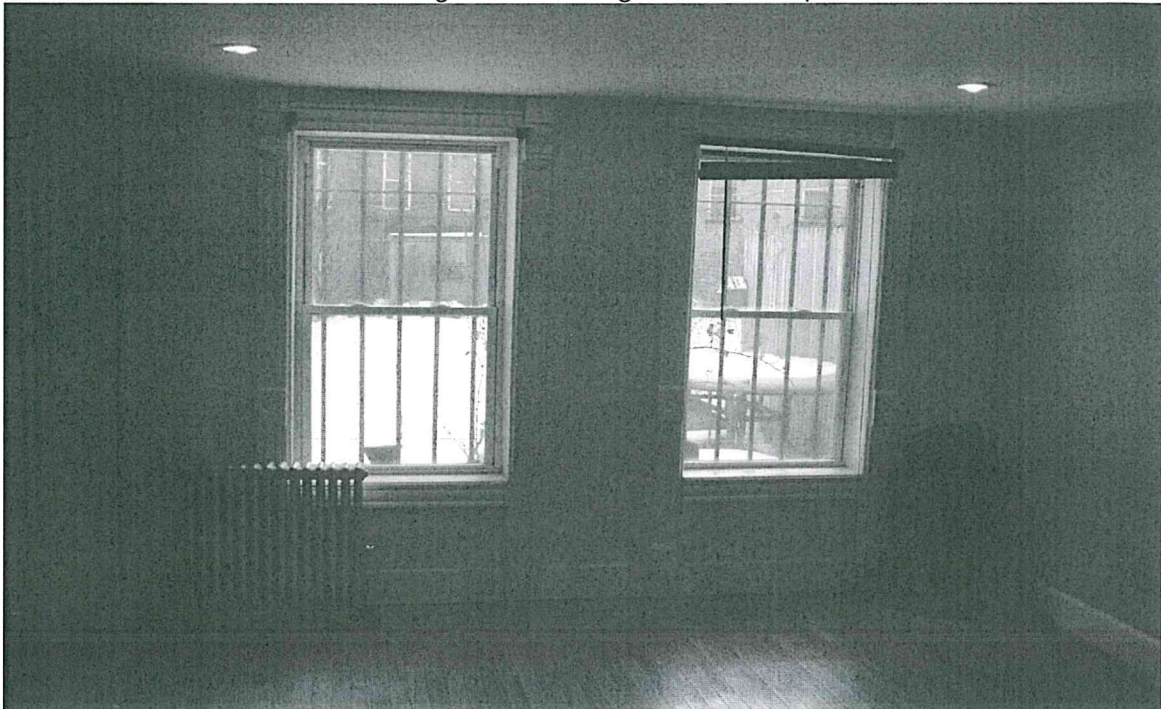
Photo 40

View of the south wall of the living room of the ground level apartment.

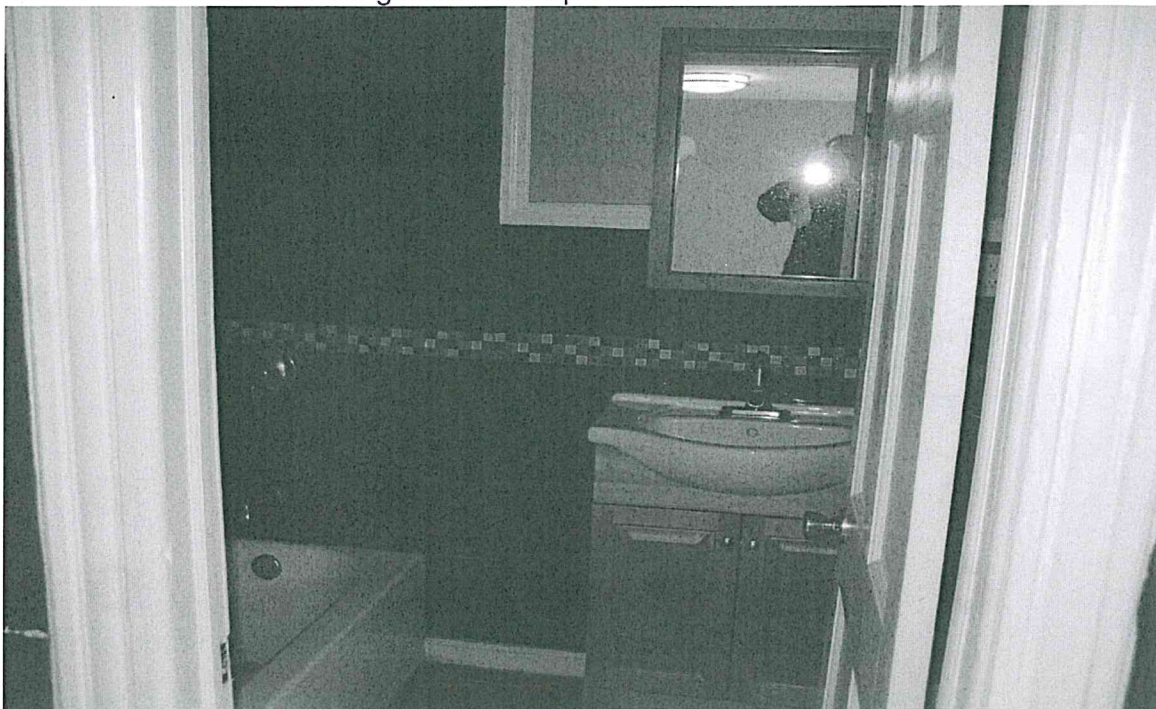
Photo 41

We inspected the bathroom of the ground level apartment. The floor covering was ceramic tiles and were in satisfactory condition. The walls and ceiling were covered with a combination of ceramic tiles and drywall. The old plaster were covered with new drywall and tiles. This method of encapsulation is acceptable. The bathroom was in acceptable condition and was constructed as per the engineering and construction industry design standards.

View of the bathroom of the ground level apartment.

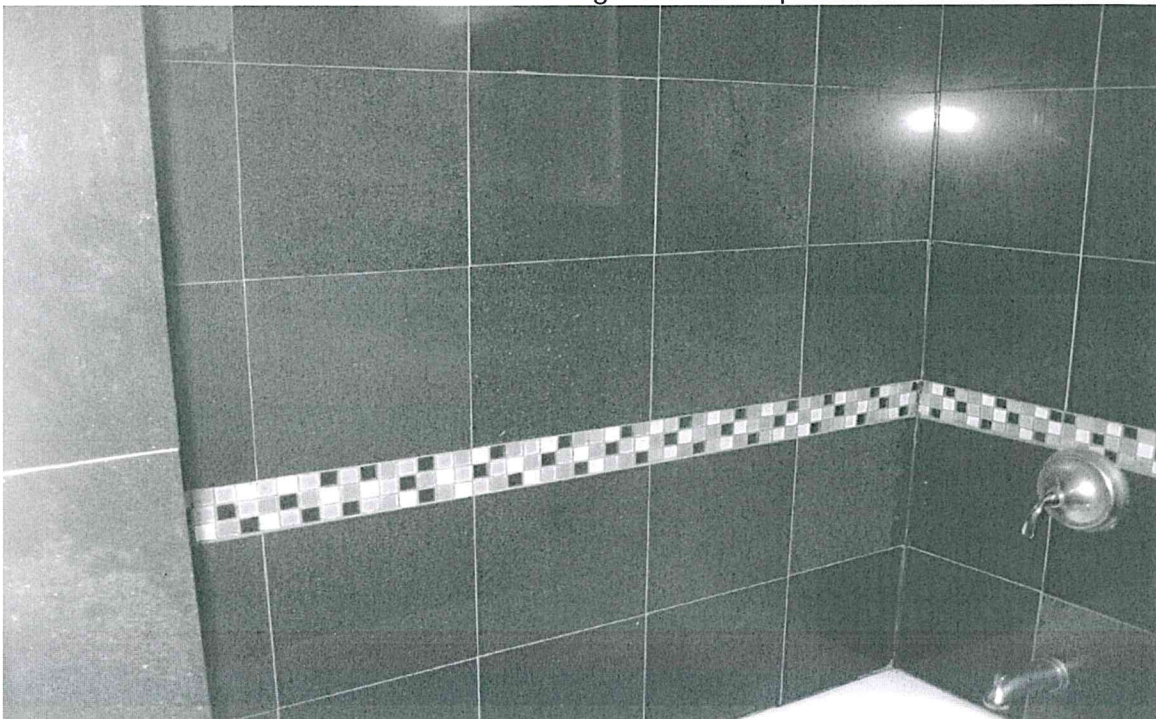
Photo 42

View of the north wall of the bathroom of the ground level apartment.

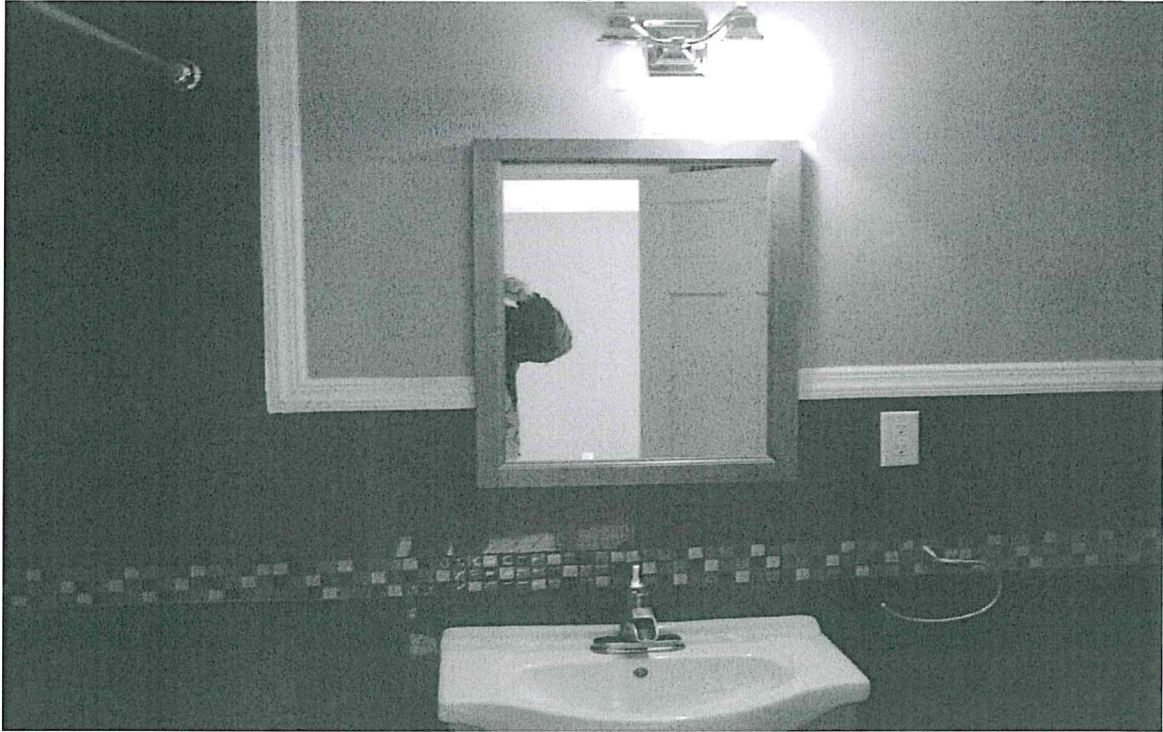
Photo 43

View of the east wall of the bathroom of the ground level apartment.

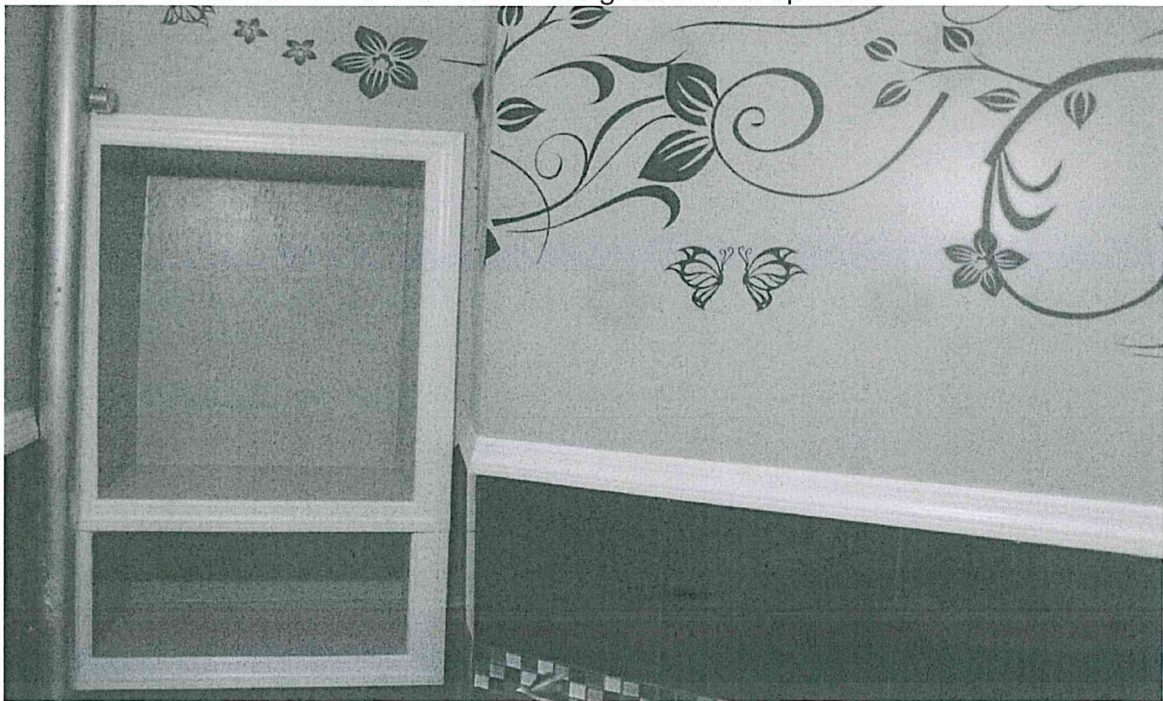
Photo 44

View of the south wall of the bathroom of the ground level apartment.

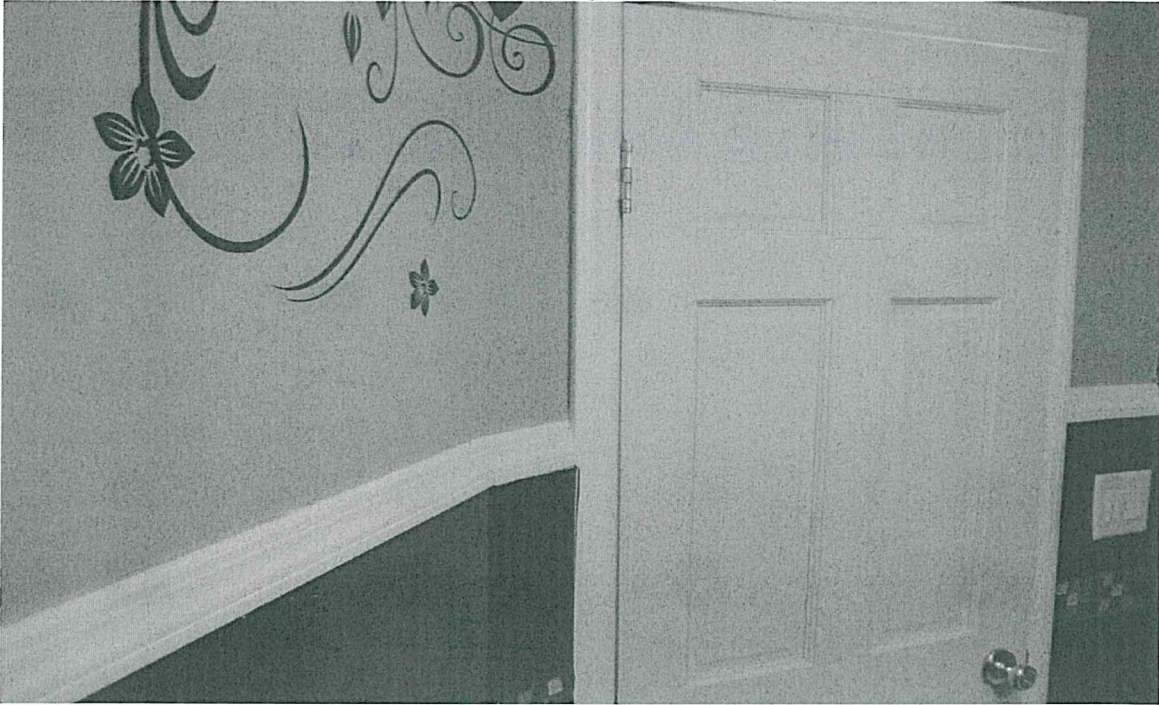
Photo 45

View of the west wall of the bathroom of the ground level apartment.

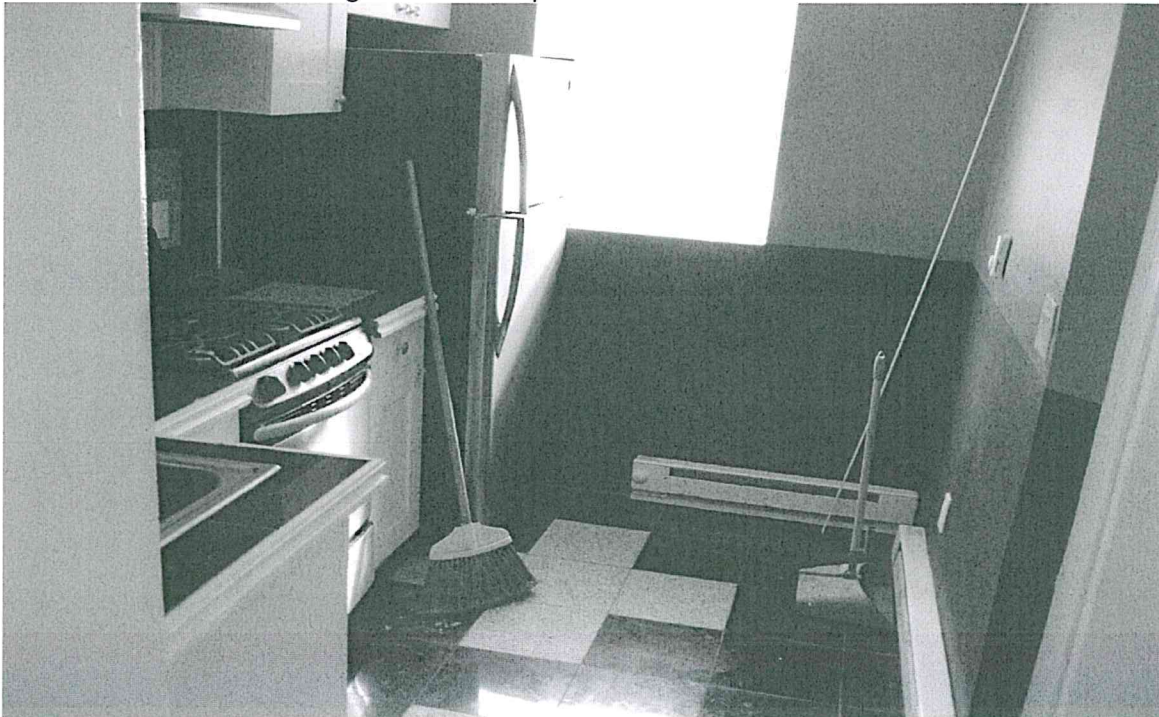
Photo 46

The ground level apartment consists of a kitchen, living room, bathroom and one bedroom. The wall, floor and ceiling coverings of the kitchen were inspected. The floor covering was ceramic floor tiles and in satisfactory condition. The cabinets, counter, appliances and the sink were in satisfactory condition. The drywall wall and ceiling coverings were installed over the old plaster wall coverings in the 2011. The new drywall wall and ceiling coverings were the proper method of encapsulation over the old plaster walls and ceilings. The new drywall wall and ceiling coverings were inspected and found to be in overall satisfactory condition and were constructed as per the engineering and construction industry design standards.

View of the kitchen of the ground level apartment.

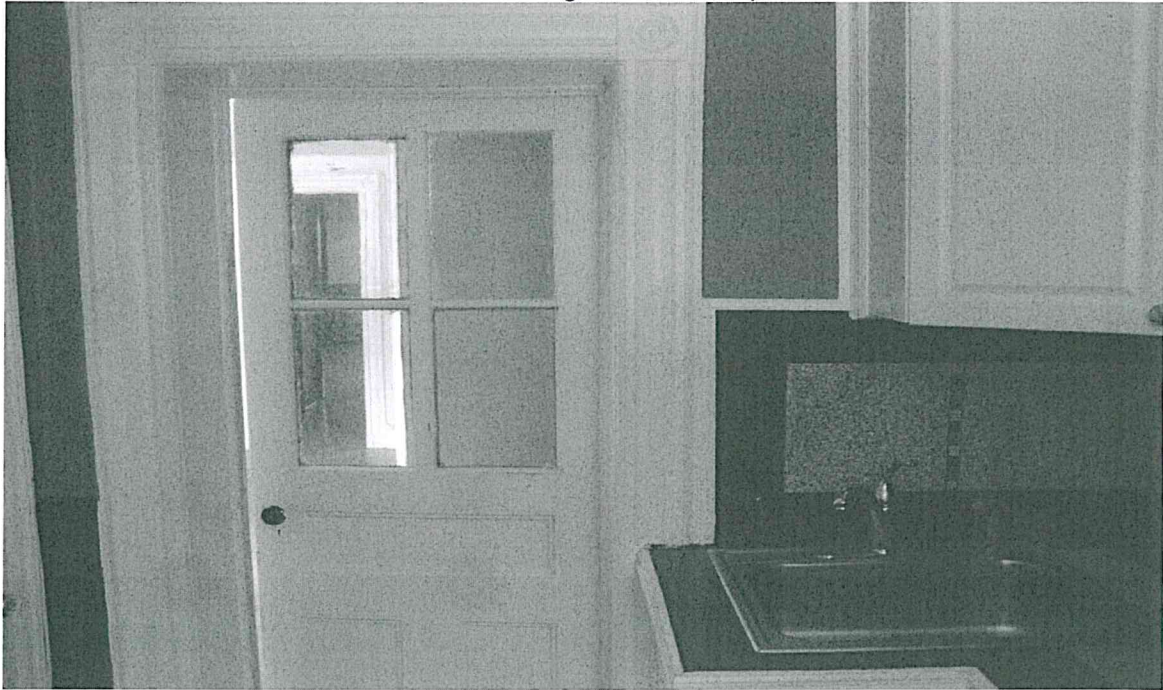
Photo 47

View of the north wall of the kitchen of the ground level apartment.

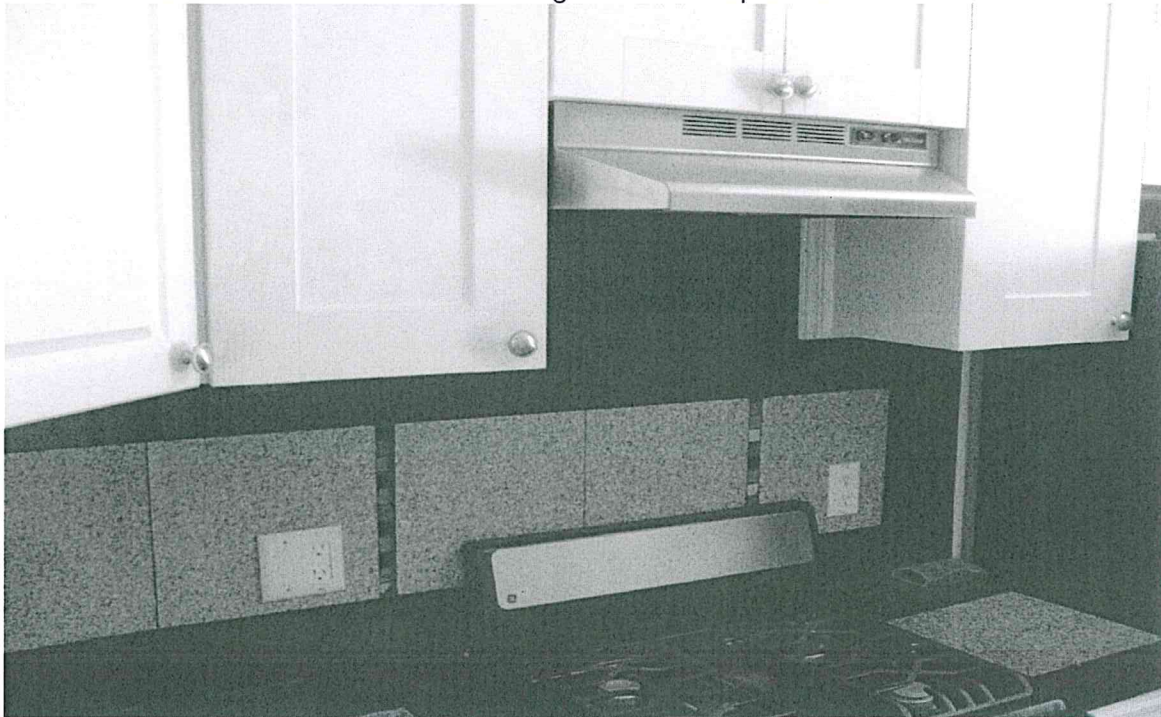
Photo 48

View of the east wall of the kitchen of the ground level apartment.

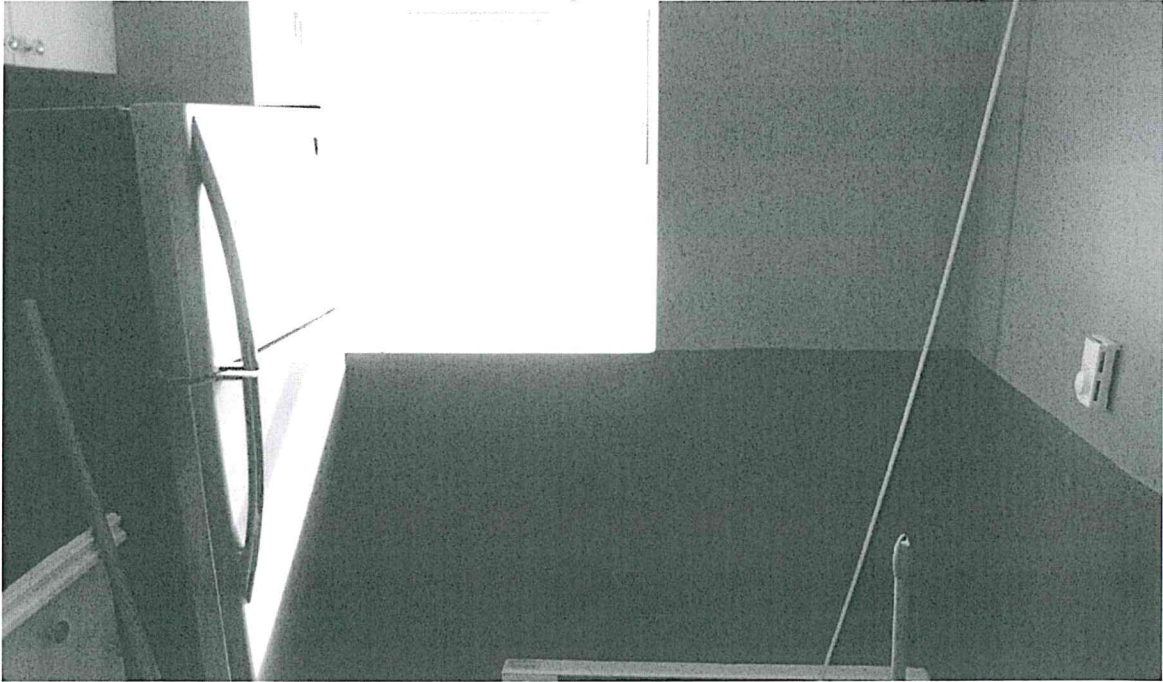
Photo 49

View of the south wall of the kitchen of the ground level apartment.

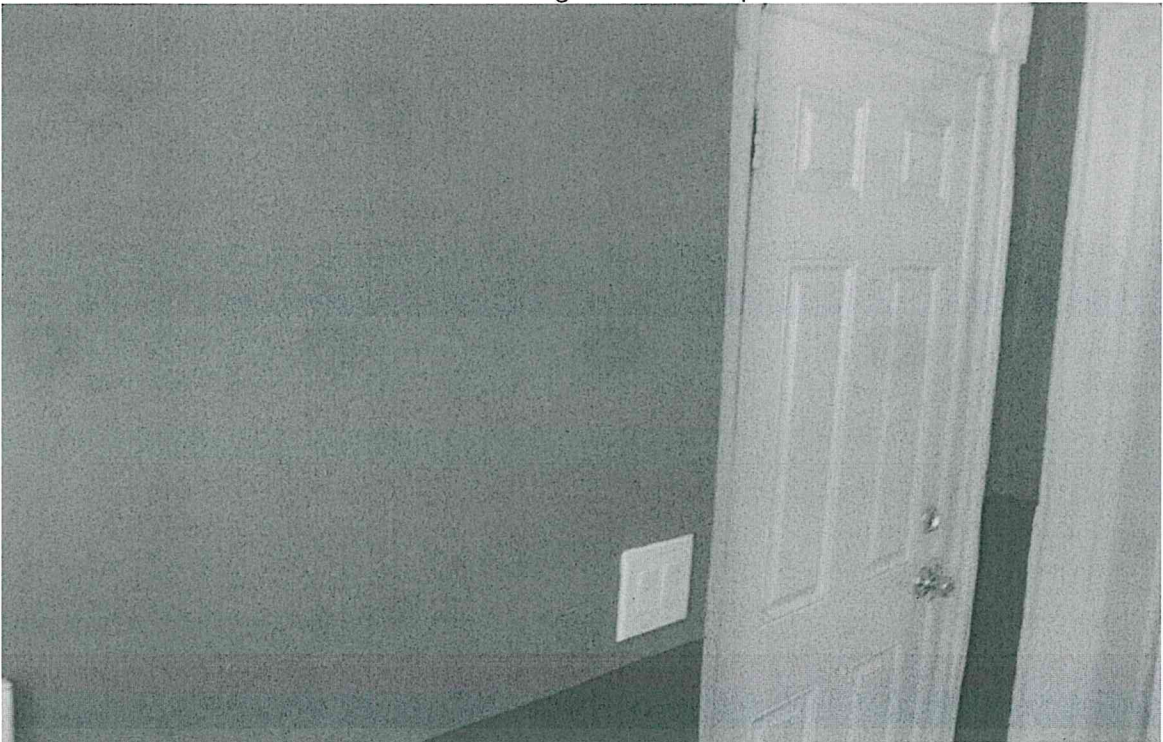
Photo 50

View of the west wall of the kitchen of the ground level apartment.
